ProChoice Home Inspection Services

Property Inspection Report

211 Windgate Ct, Peachtree City, GA 30269
Inspection prepared for: Eric Gleaton
Real Estate Agent: -

Date of Inspection: 3/12/2017 Time: 2:00 PM
Age of Home: 1985 Size: 1368
Order ID: 44

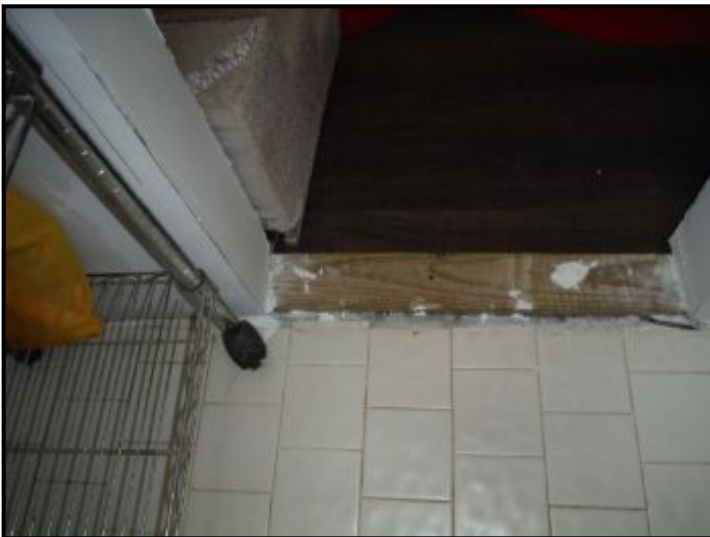
- Tile floor in master bath is unfinished. Missing tile at garagen tub. Missing transition tiles at doorways. Missing tile baseboard.

Unfinished tiles in door frames.

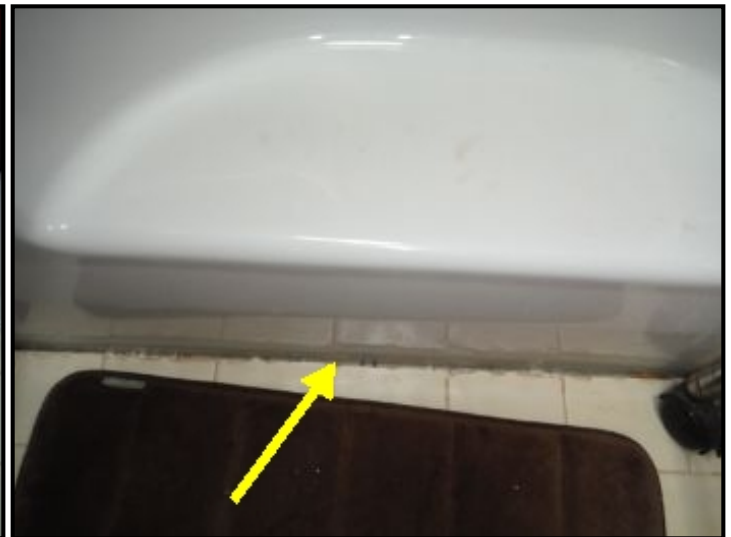
Missing tiles at garden tub.

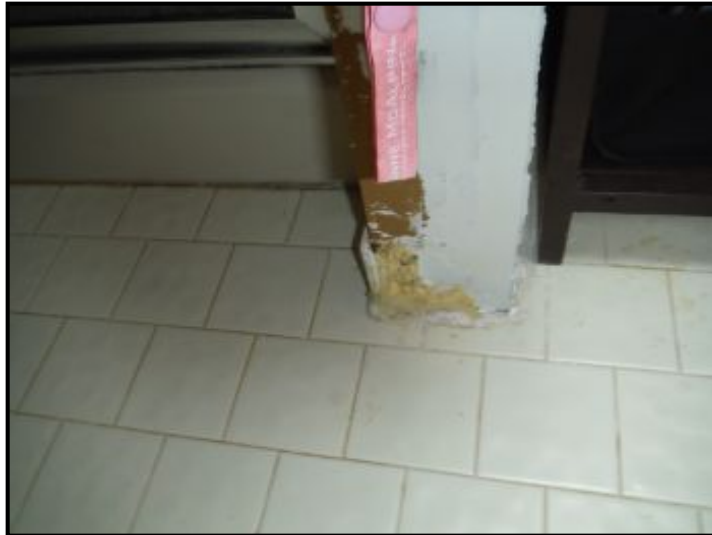
Missing baseboard tiles.

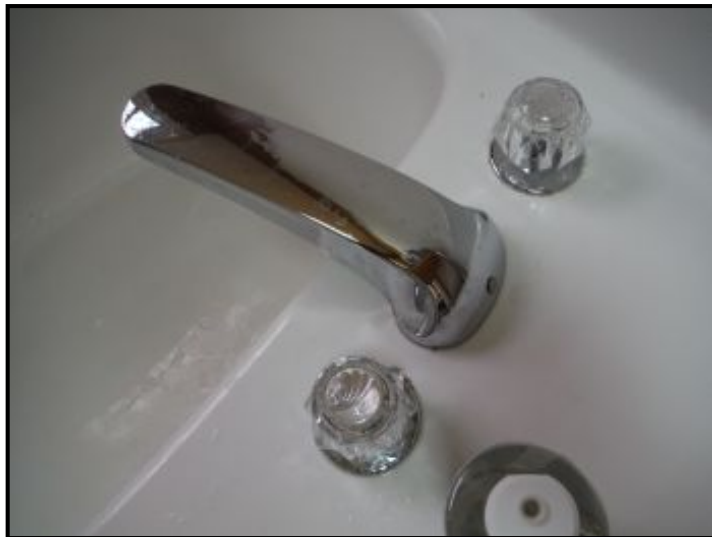
Observations:
• **Garden Tub functional. Tighten the loose faucet.**

Tighten handle on garden tub.

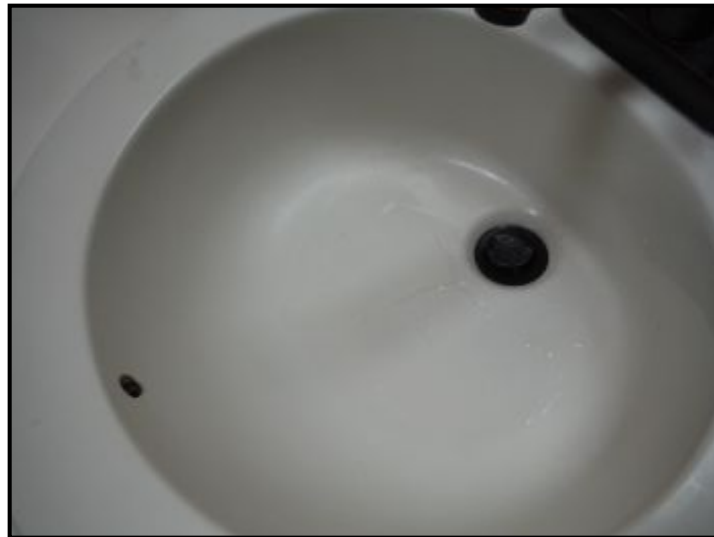
Observations:
• **Sink bowl in master bath is cracked. Replace.**

Cracked sink bowl.

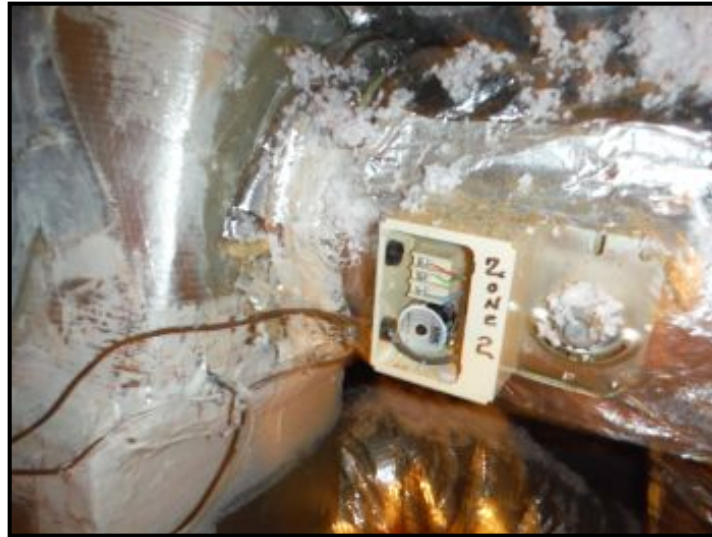
- The air supply system appears to be functional.
- The duct has a damper zone system installed that does not appear to be functional. In the inspectors opinion it is not needed for a house of this square footage. Recommend disconnecting system.

Damper system on ducts.

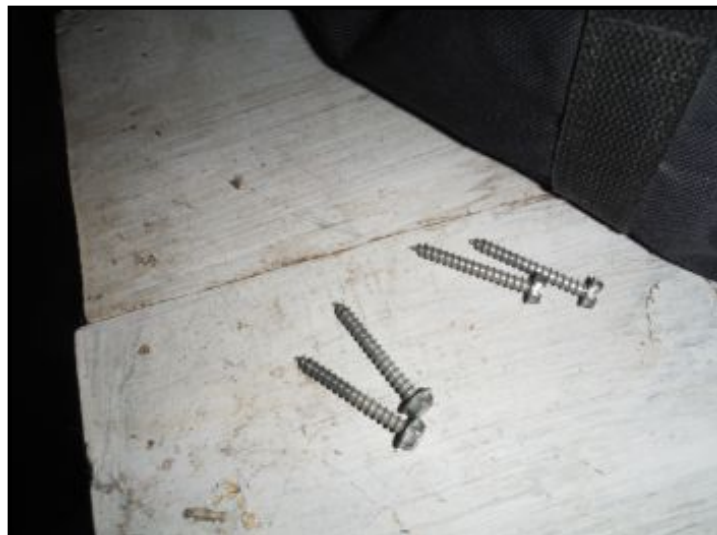
Panel cover screw should not have pointed ends.
Can damage wiring.

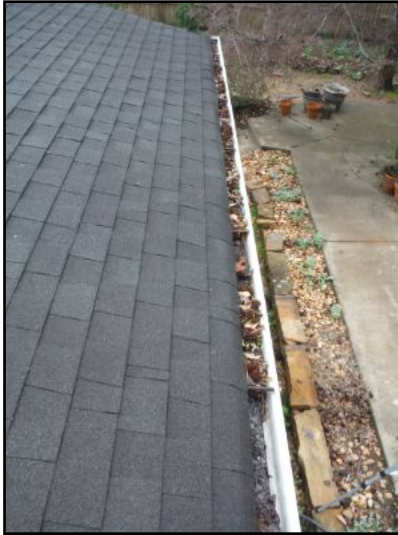
- Clean gutters: Significant amounts of debris evident.

Gutter need cleaning.

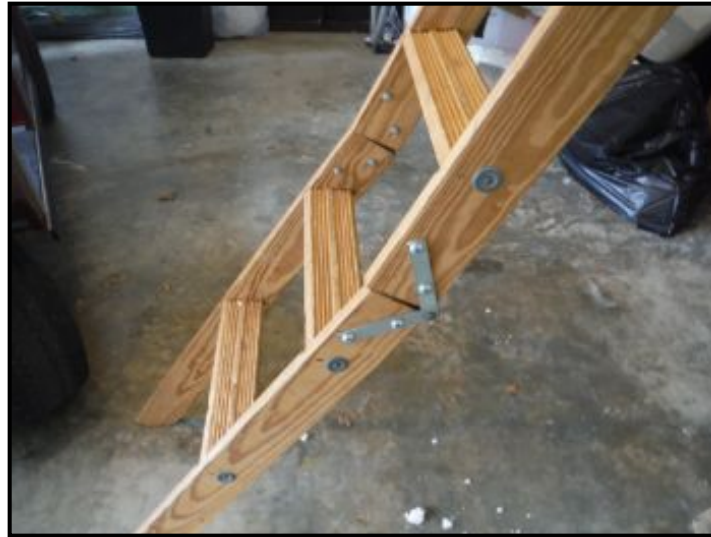
- Pull Down Ladder located in garage.
- Reinforce the bottom section of pull down stair.

Strengthen folding stair.

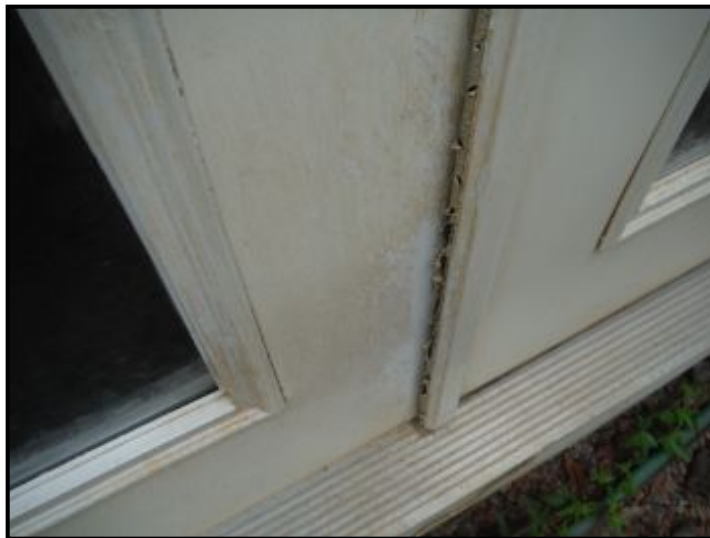
- Slight damage to the weather stripping on the side entry door.

Damaged weather strip on side entry door.

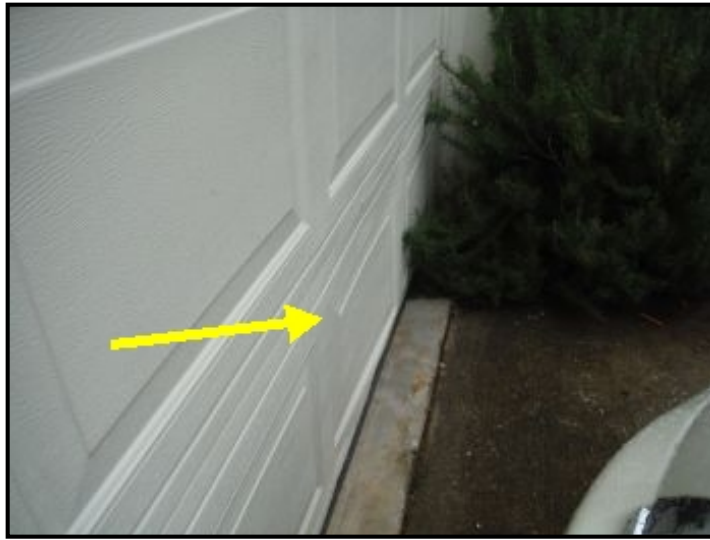
- Single aluminium paneled door. Some minor dents in door. Functional.

Slight dent in garage door.

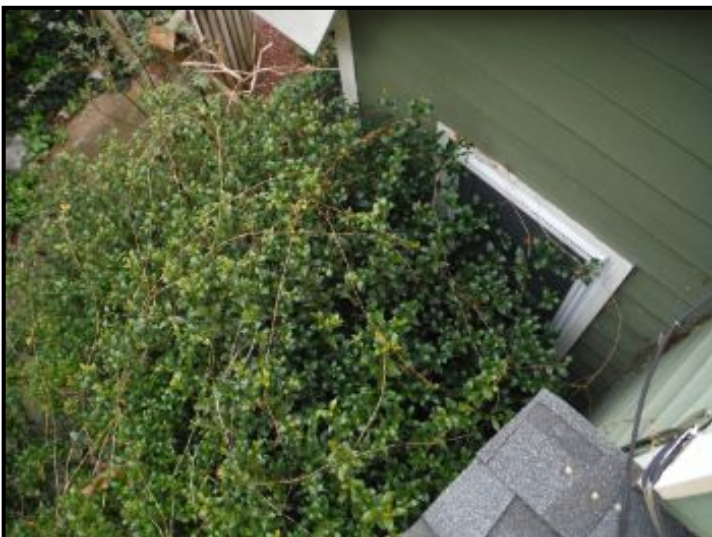
Trim or remove over grown shrubs.

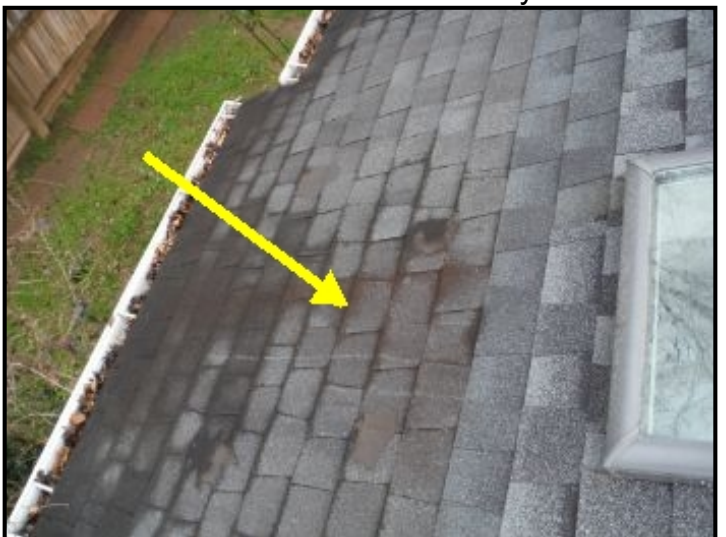
- Repairs noted around both skylights. Decking is rotted below the repaired shingles at the master bath area. Not able to access attic areas where the skylights are installed. No obvious signs of leaks at time of inspection.

Rotted decking below master bath skylight.

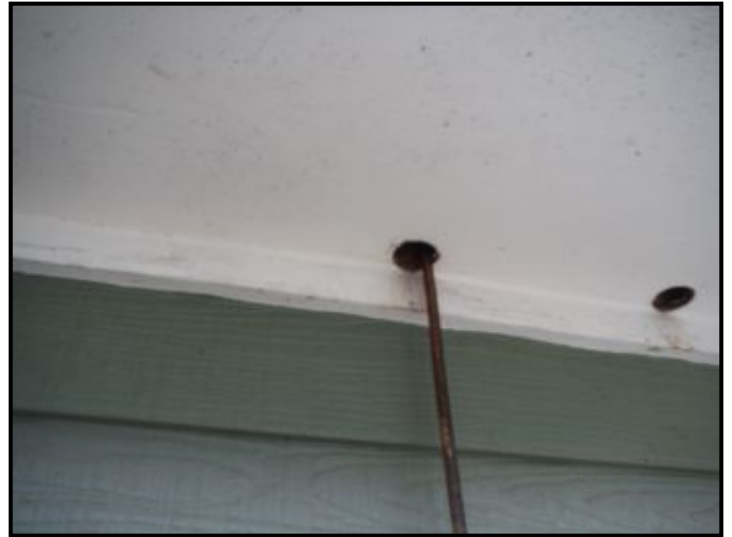
Seal holes in soffit above the water heater.

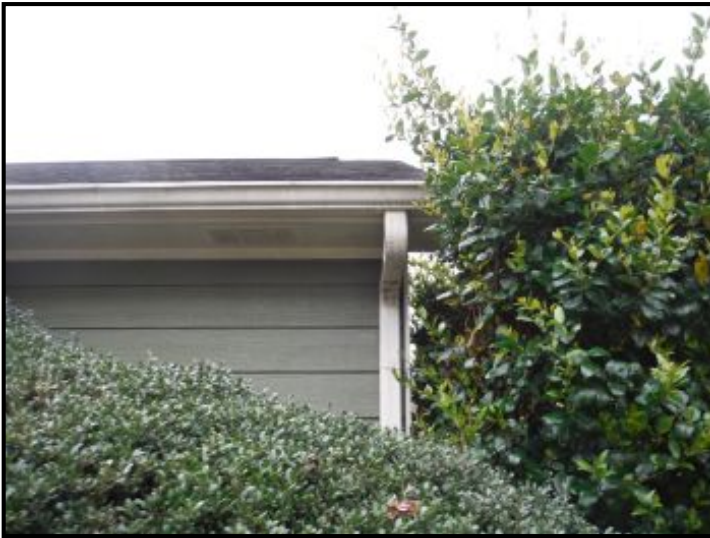
Trim shrubs.

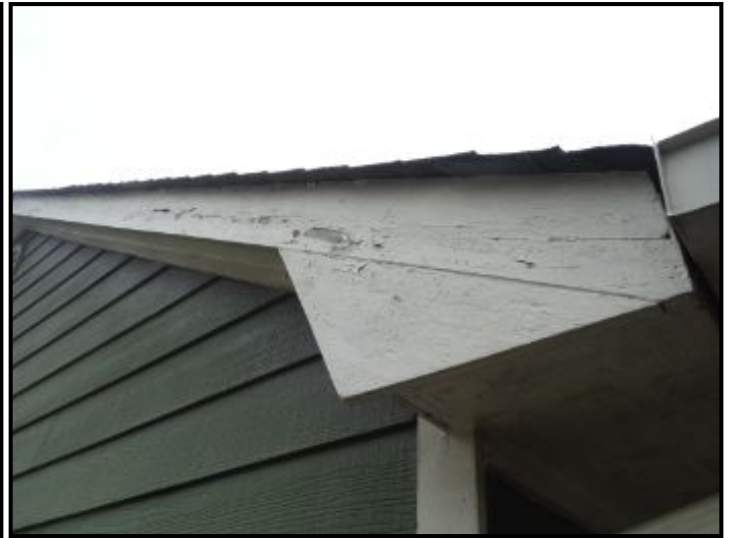
Peeling paint on fascia.

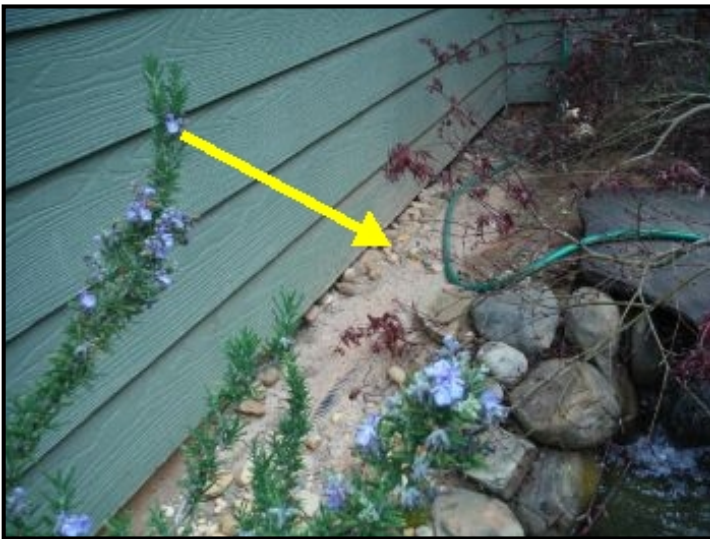
Remove soil at garage wall to

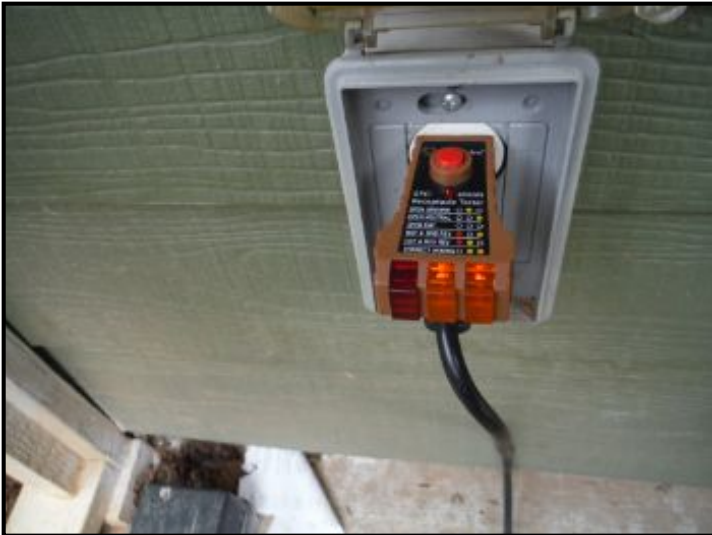
Exterior outlets should be GFCI protected.

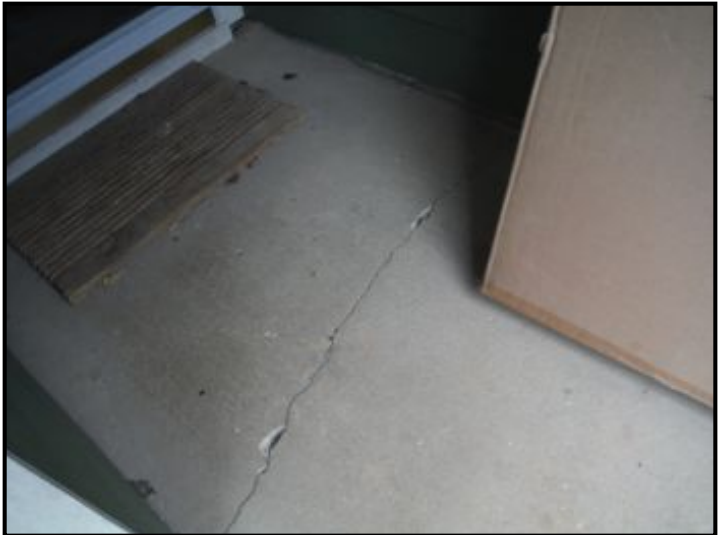
Cracks in side walk.

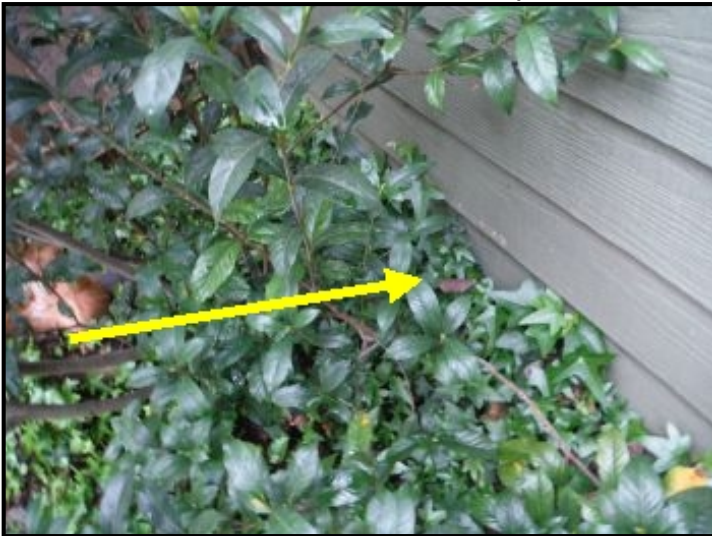
- The foundation perimeter should be visible on all sides for proper monitoring of termites. Remove any soil or ground cover that cover the slab.

Remove ground cover to expose foundation.

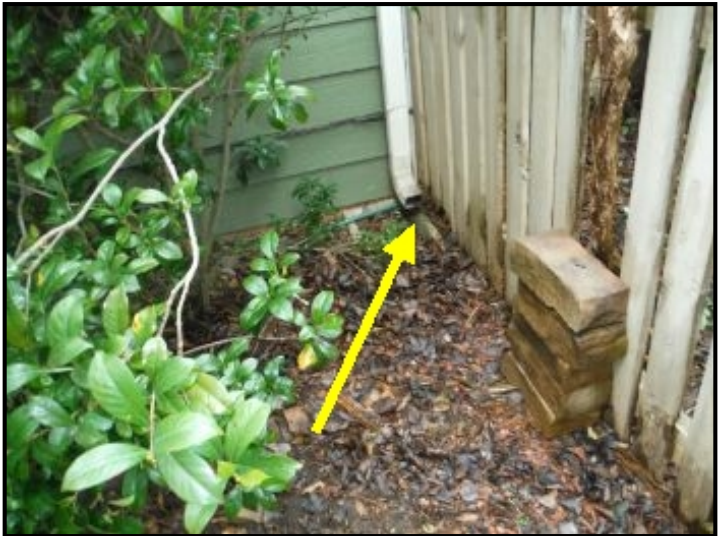
Add extension pipes to downspouts.

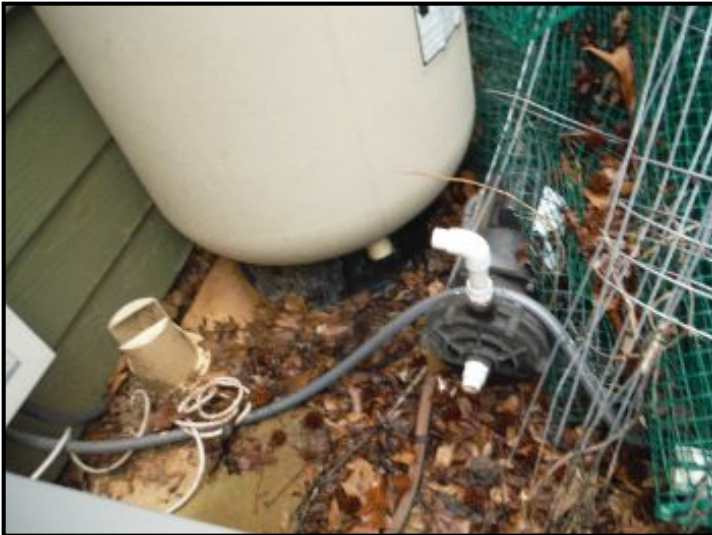
Suggest removing pool pump and filter. Pool has been filled in.

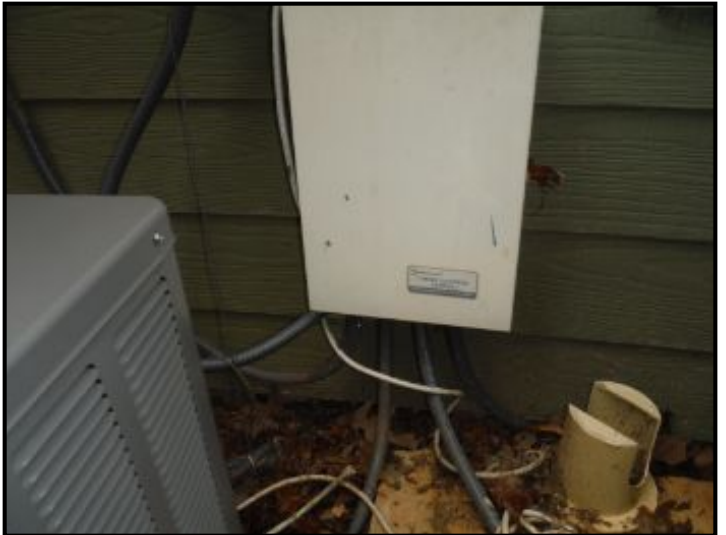
Suggest removing all electrical wiring for pool pump.

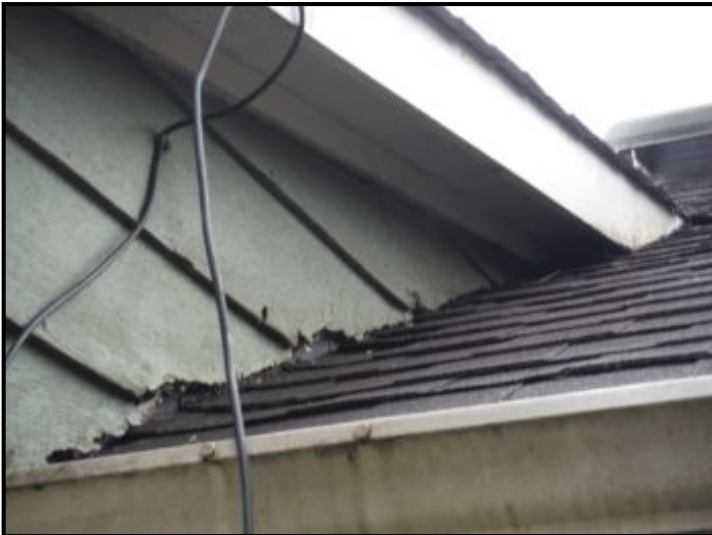
Damaged siding on rear porch addition.

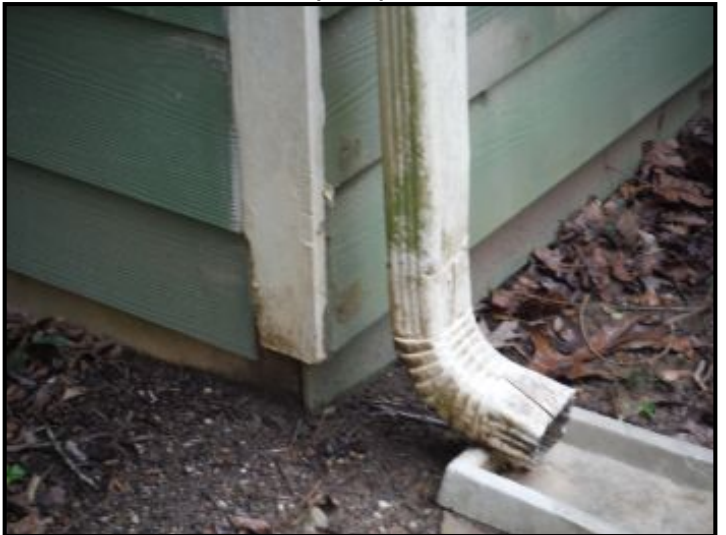
Secure the downspout to the exterior wall on left rear corner.

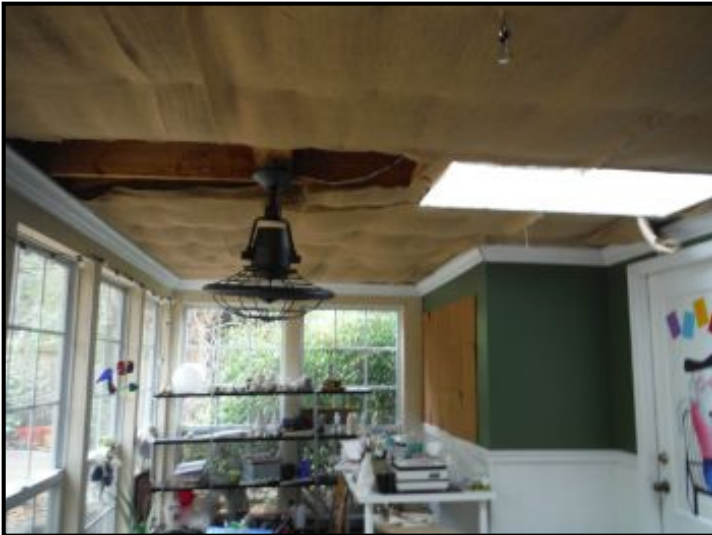
Ceiling to rear porch addition has been removed. Covered with cloth. Not able to visually inspect framing.

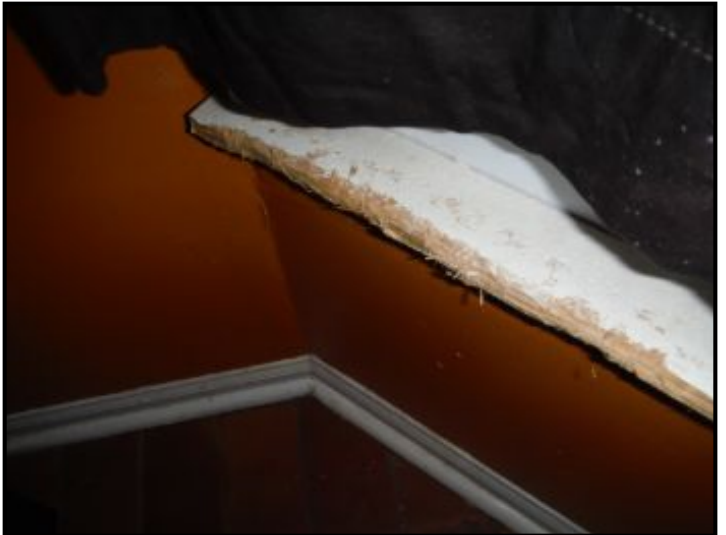
Damaged window trim in kitchen.

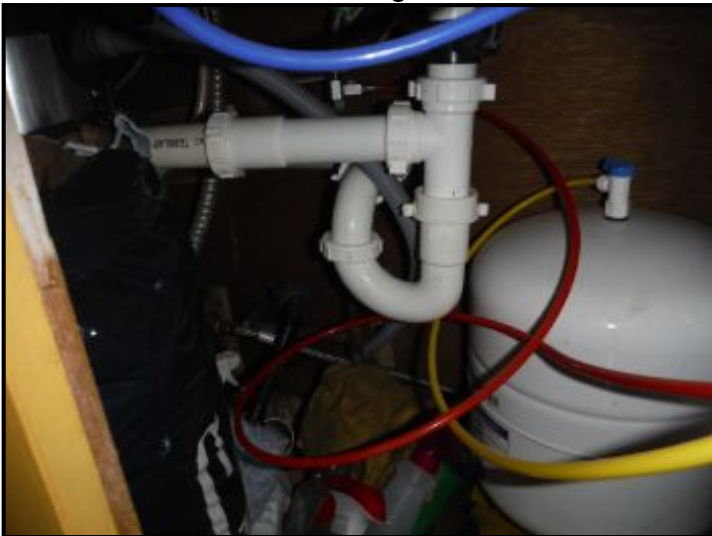
- Several of the lower cabinet doors and drawer faces have been damaged by animals chewing on them.
- Bottom of sink base cabinet is missing.

Kitchen sink base bottom has been removed.

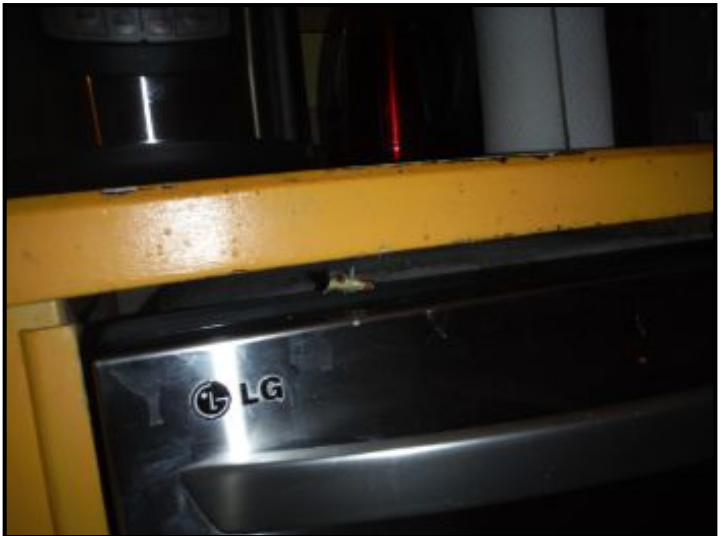
Secure dishwasher to cabinet.

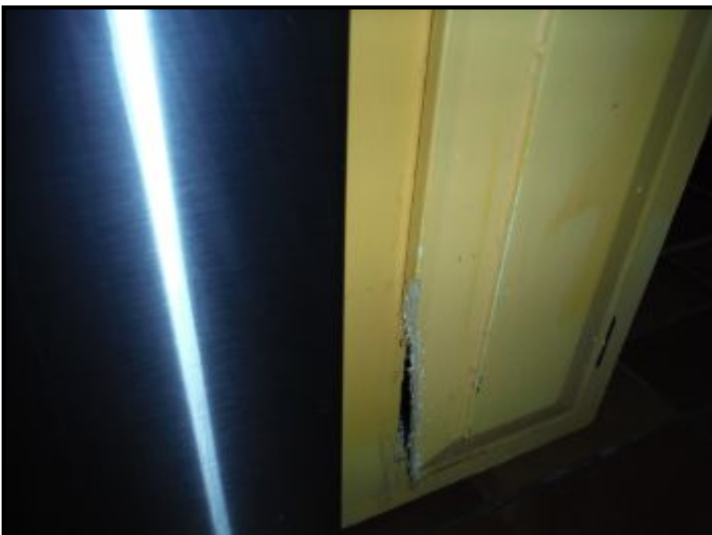
Damaged kitchen cabinet doors.

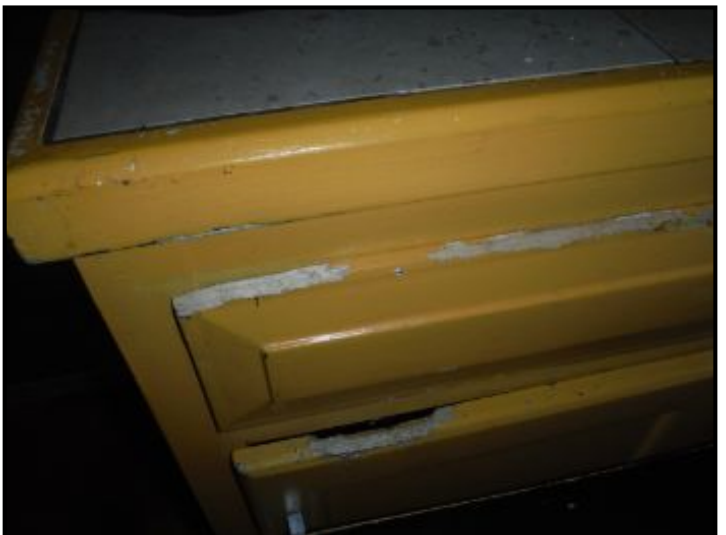
Damaged kitchen cabinet drawers.

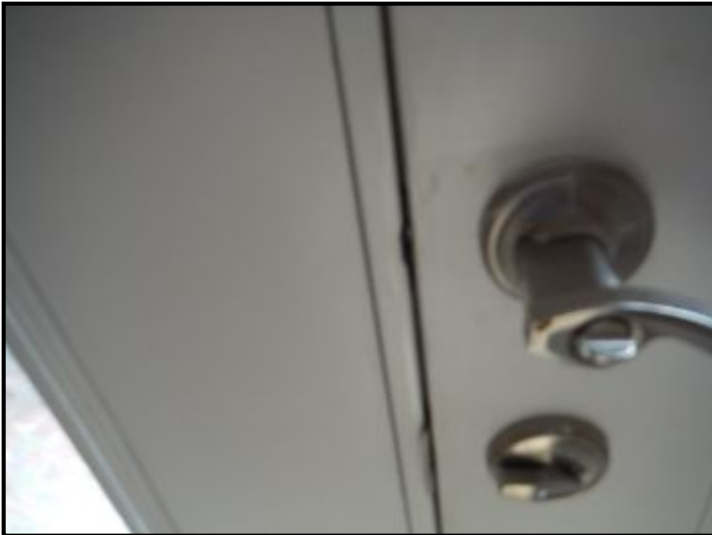
Door latch to side door does not catch. Adjust the strike plate.

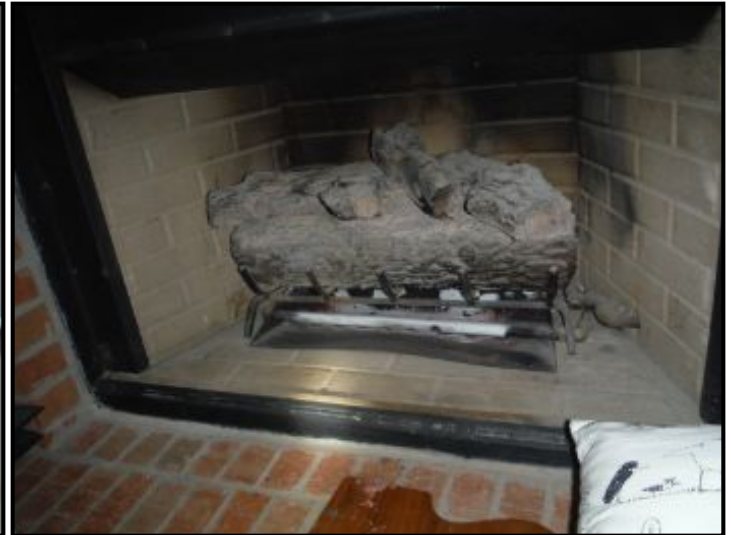
View of fireplace. Screen is missing.

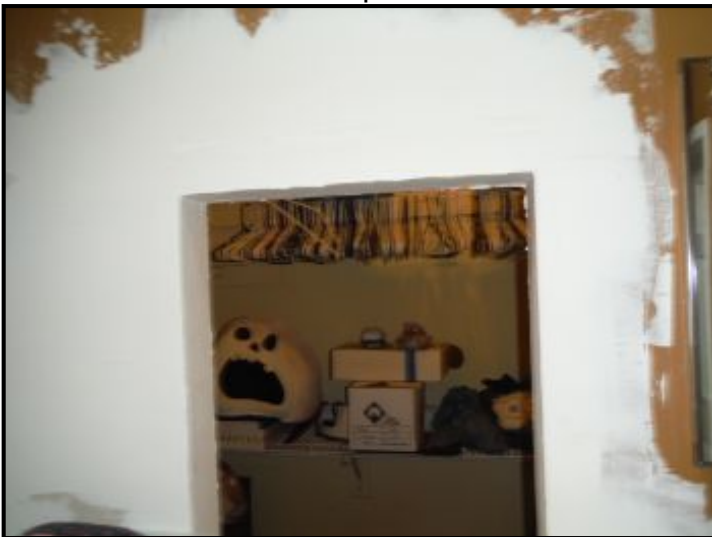
Not a normal size door frame in master bath.

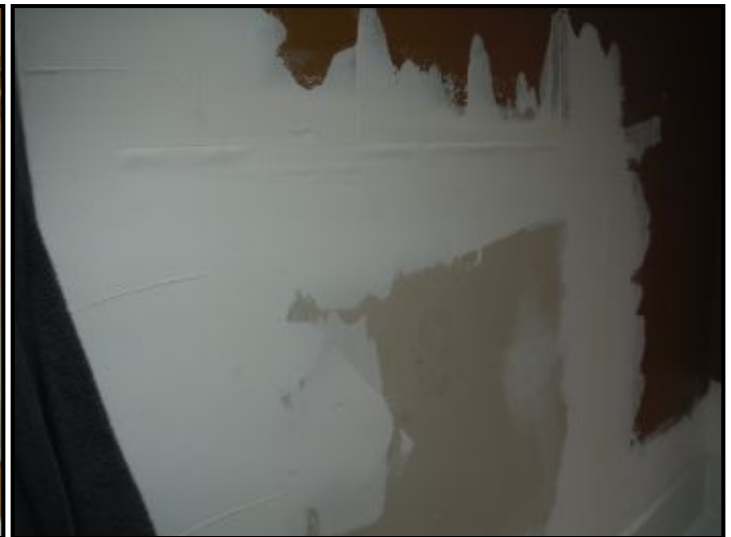
Walls in bath are not properly finished.

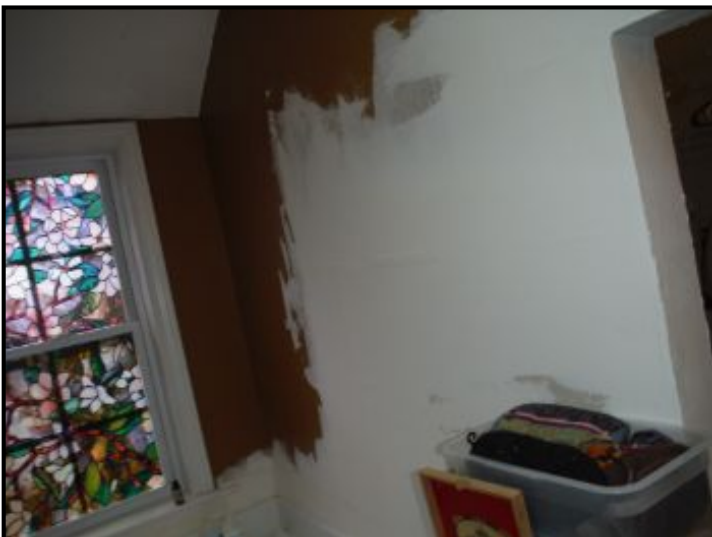
Unfinished walls in master bath.

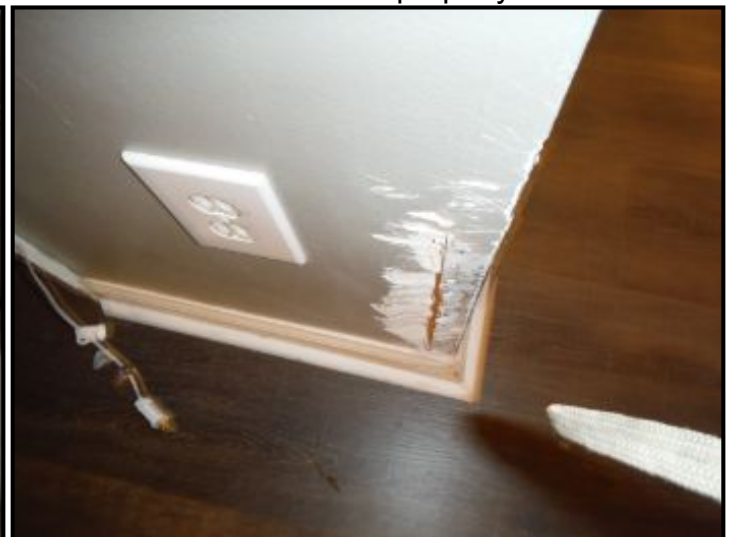
- Several places in house were the drywall has been damaged. Repair as needed.

Damaged wall in rear bedroom.

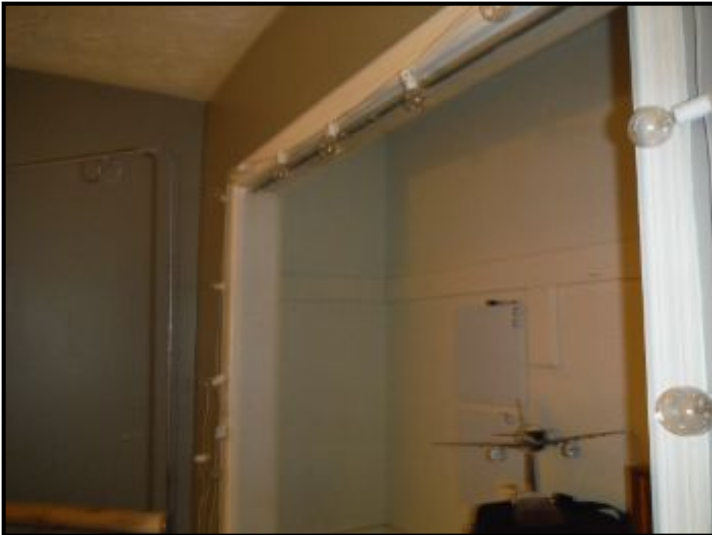
- The closet door was missing in rear bedroom.

Missing closet door in rear bedroom.

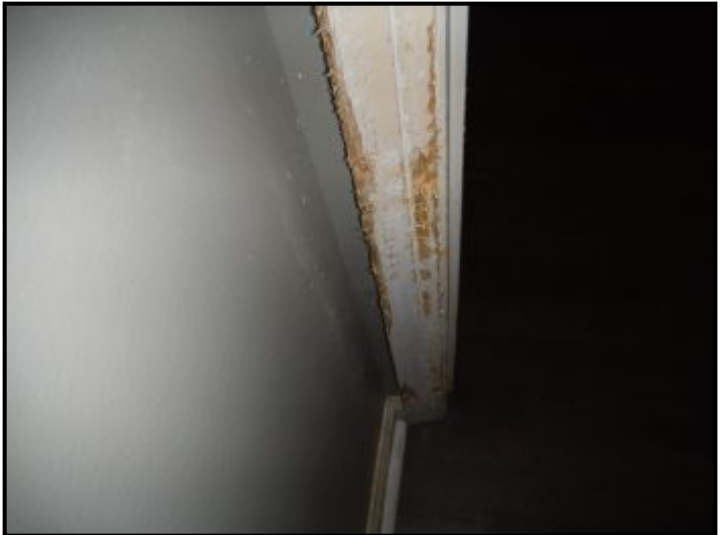
Damaged door molding in rear bedroom.

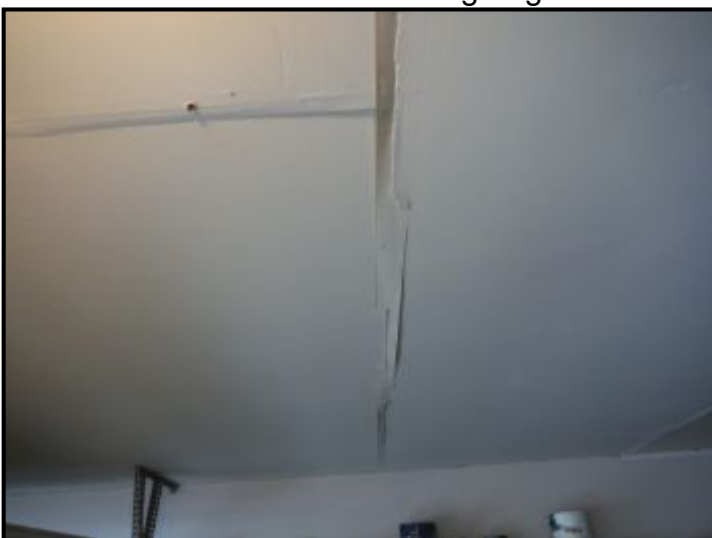
- Drywall noted on ceilings and walls of garage. Peeling paint and loose drywall tape noted.

Ceiling tape coming loose in garage.

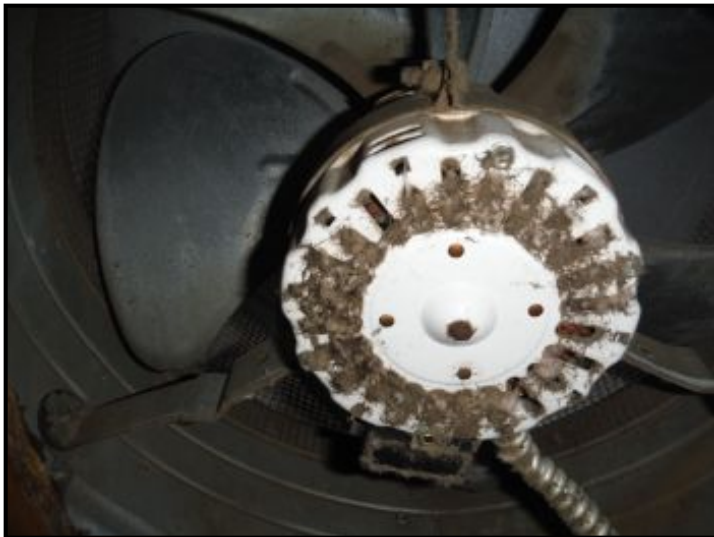
Clean the vent fan in attic.

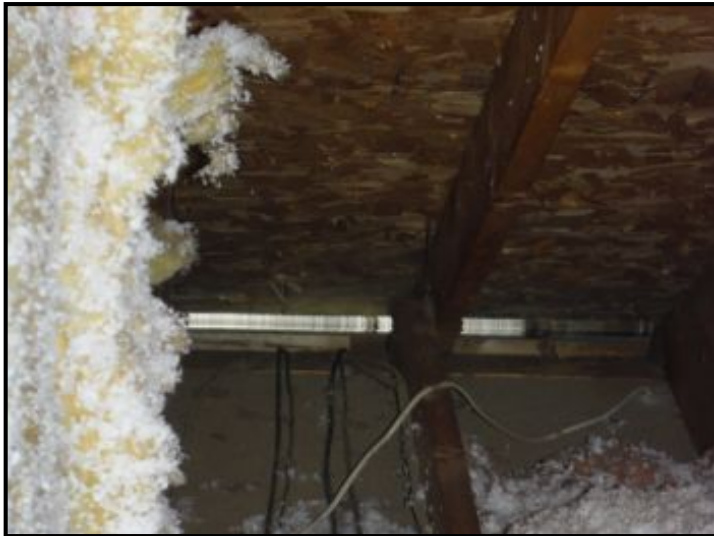
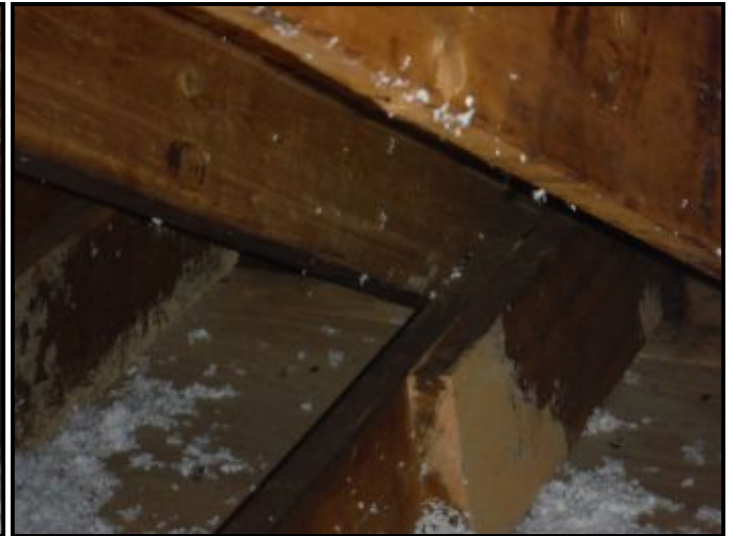
- Insulation has been removed over kitchen area. Replace.

Missing insulation over kitchen. Replace.

Missing insulation over kitchen.

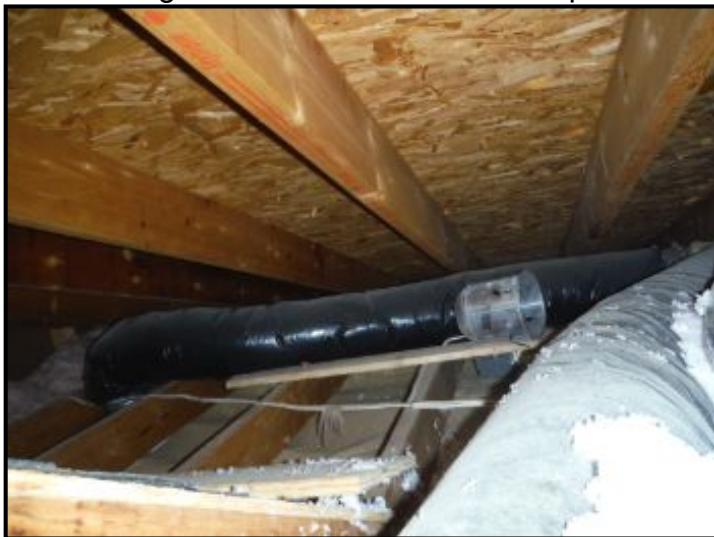
View of attic area over the porch addition. Insulation needed.

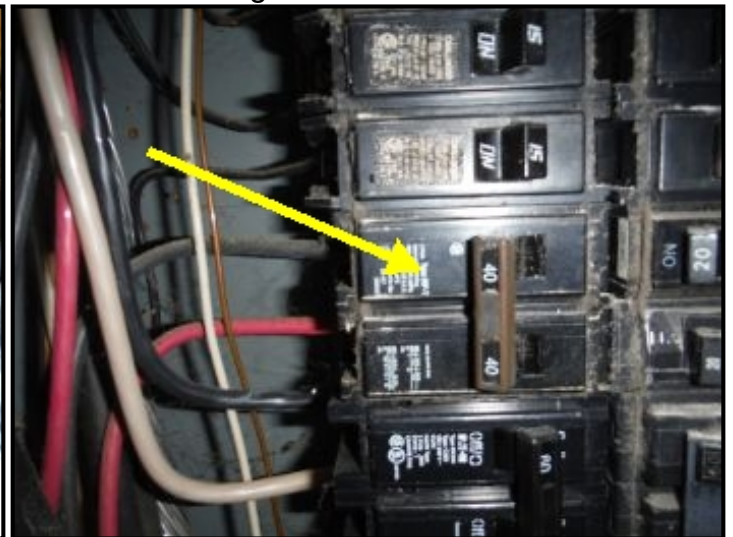
- No major system safety or function concerns noted at time of inspection at main panel box.
- **Recommend that the wiring connected to the 220v breaker that once serviced the pool be removed.**

Breaker for pool pump. Pool no longer exist.
